TEST REPORT

Report of testing National Forest Products Cedar Pinnacle Shingle Panel for compliance with the applicable requirements of the following criteria: **SFM Standard 12-7A-1 – Materials and Construction Methods for Exterior Wildfire Exposure – Exterior Wall Siding and Sheathing.**

104146525COQ-002

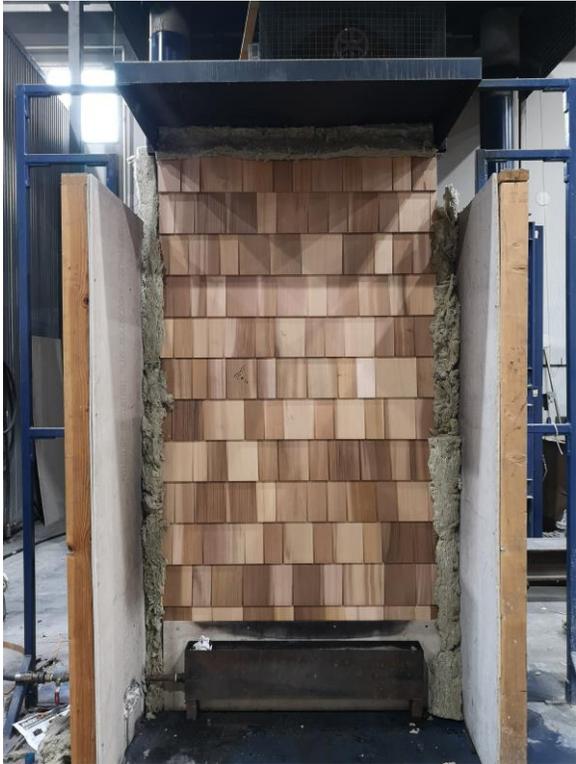
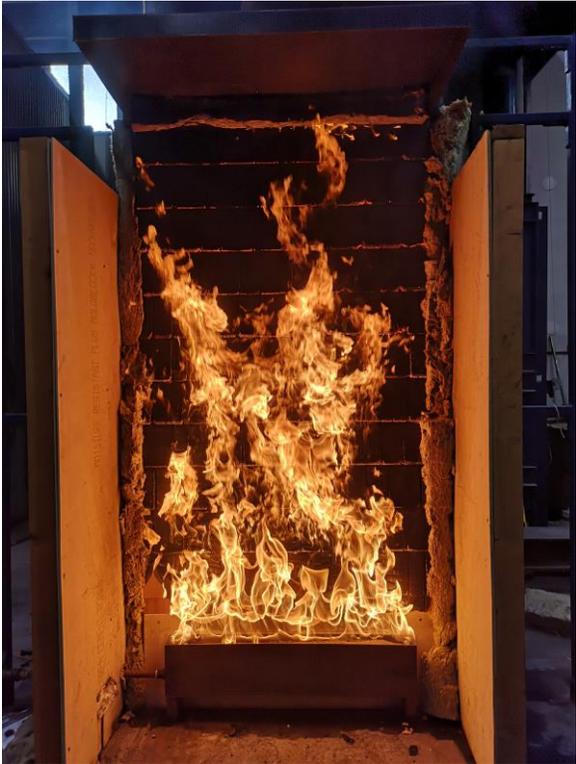
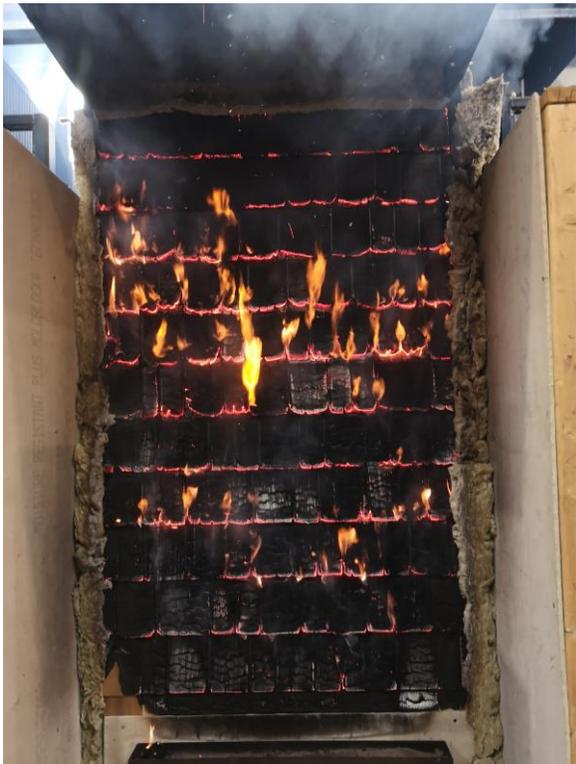
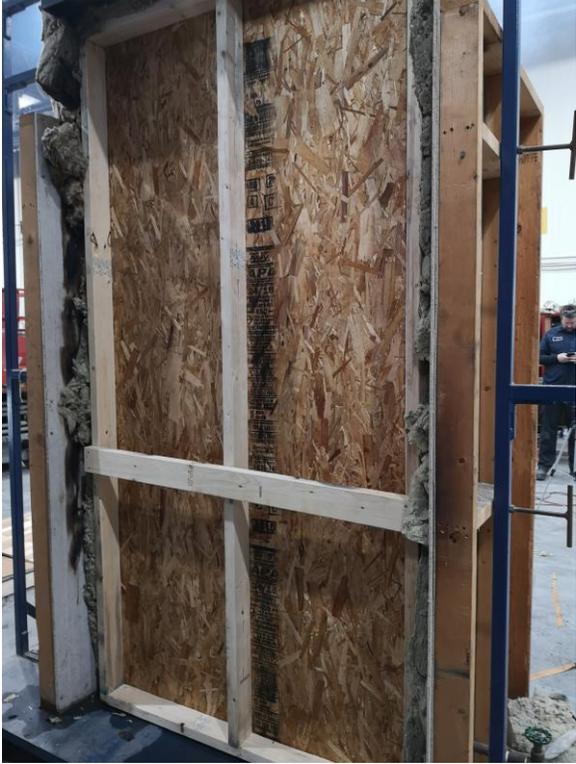
Test 1

Time	Observation
0:00	Start of test.
0:25	Crackling and discolouration
4:00	Entire surface charred.
10:00	Burner stopped. Flaming continues on surface.
11:40	Ignition remains in the middle. Smoke released.
22:09	Light glowing and flaming continue. Flaming at lower middle.
27:16	Minor flaming bottom/middle. Smoke continues.
36:42	Only minor glowing on surface remains.
43:00	Reduction in smoke and glowing.
61:00	All signs of combustion ceased. End of test declared.

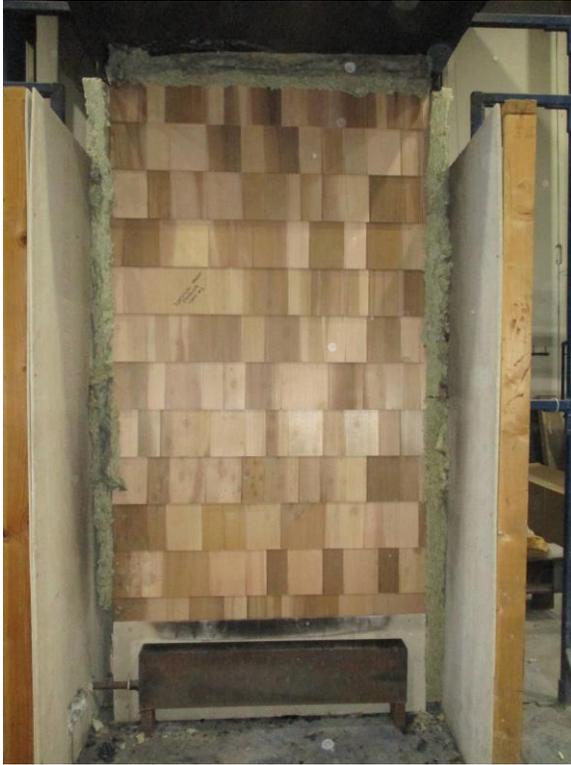
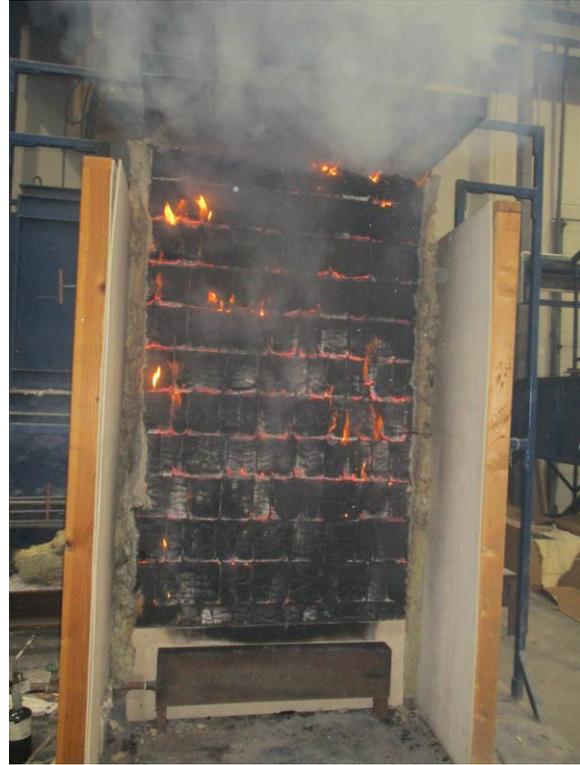
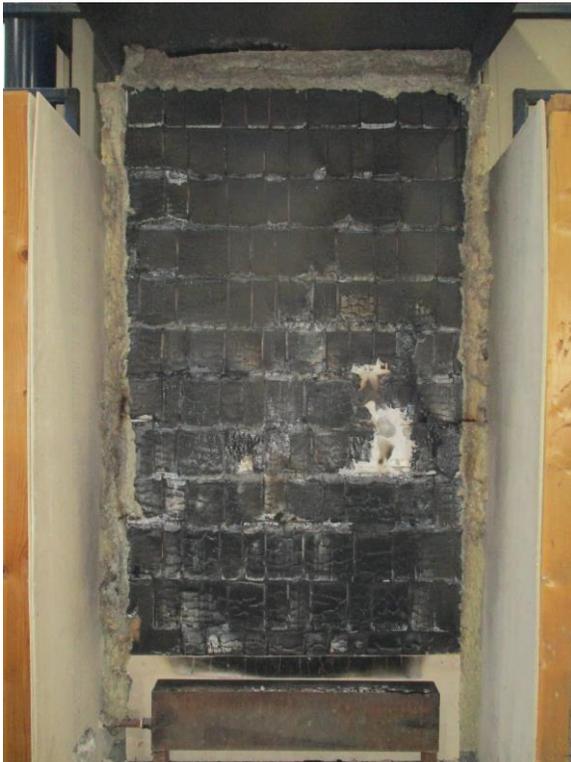
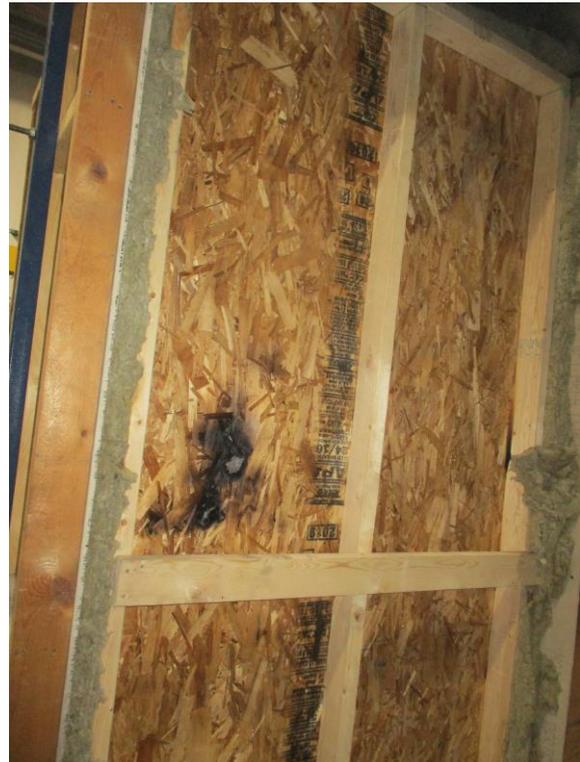
Test 2

Time	Observation
0:00	Start of test.
0:30	Ignition on surface.
1:12	Surface discoloured. Flaming increased on surface.
3:00	Surface charred. Flaming decreased.
4:14	Flaming at top; reignition.
9:00	Increased flaming on surface.
10:00	Burner stopped. Flaming on surface continues.
13:12	Flaming at middle of sample.
18:15	Only minor glowing on surface remains besides middle flaming.
27:05	Only flaming remaining on mid-right.
31:23	Glowing remaining at mid-right. Smoke released along stud on backside.
37:50	Pin holes forming on backside.
40:05	Re-ignition at mid-right. Hot spots forming on backside.
51:25	Hot spot increasing in size and char.
61:45	No flaming or glowing on surface. Hot spots continue.
70:00	End of test.

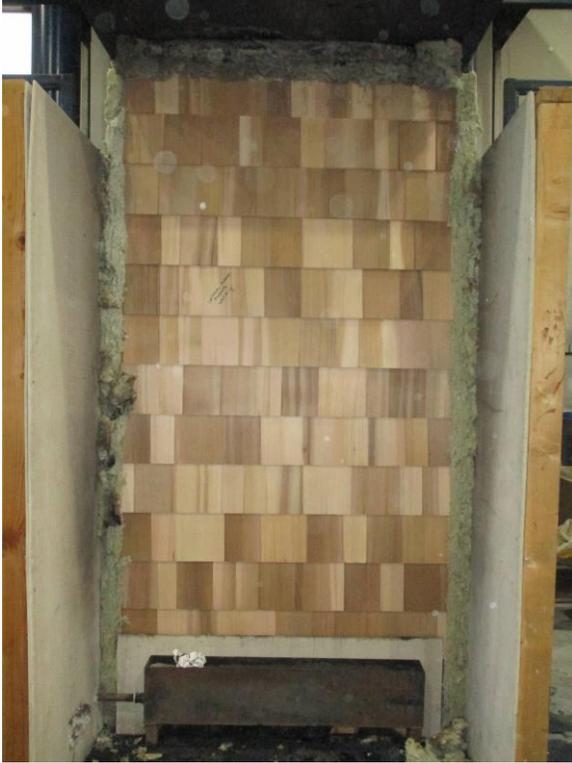
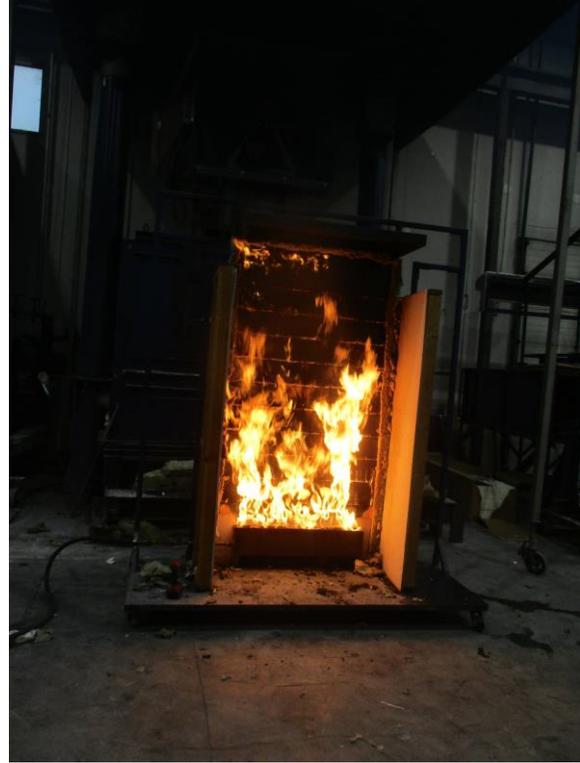
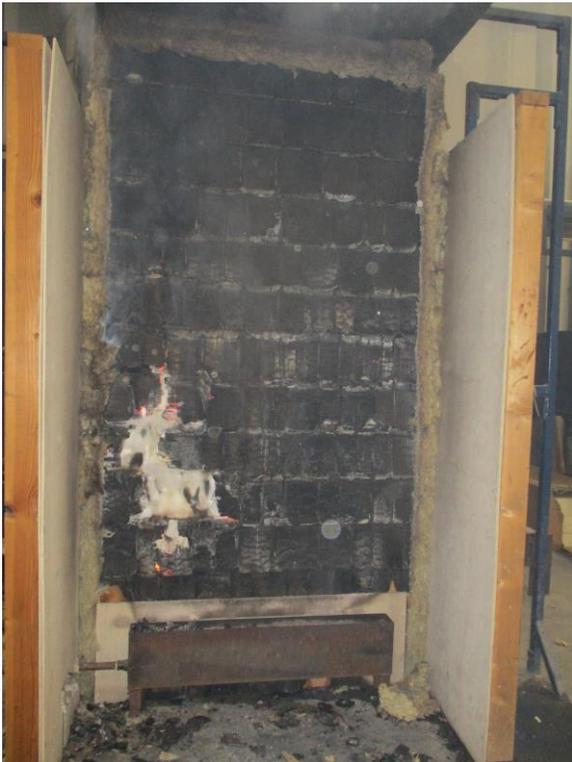
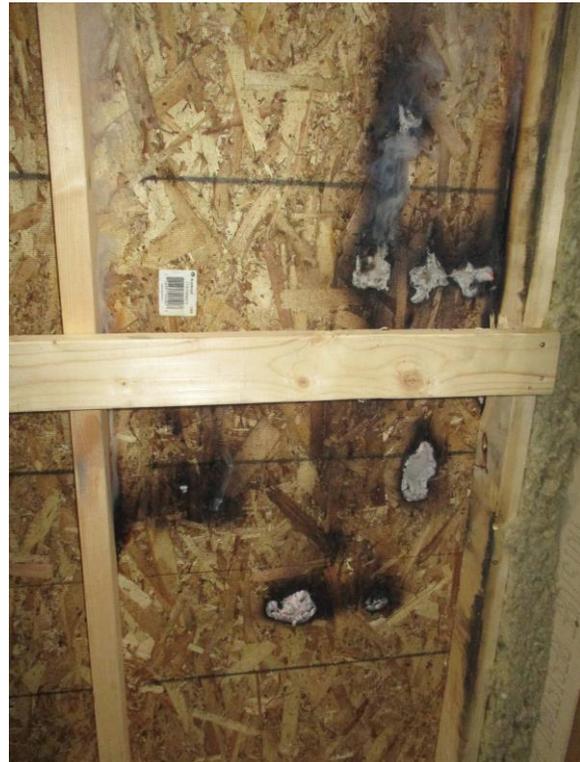
Test 3

Time	Observation
0:00	Start of test.
0:30	Ignition on surface.
1:00	Surface discoloured.
5:35	Flaming on surface reduced.
10:00	Burner stopped. Flaming on surface continues.
14:00	Flaming remains on lower left.
25:32	Flaming continues.
28:00	Pin holes forming on backside.
30:30	Panelling falling away as it burns.
37:00	Flaming continues at mid-left. Hole formed at hot spot at right on backside.
46:45	Flaming on surface continues. Hot spots increase on back side.
52:22	Flaming remains lower left.
56:00	Flaming at lower mid.
68:00	Minor flaming on surface. Hot spots reducing.
70:00	End of test.
